# Fluorescent Tracer Tests for detection of dam leakages: the case of the Bumbuna Dam - Sierra Leone

## Summary

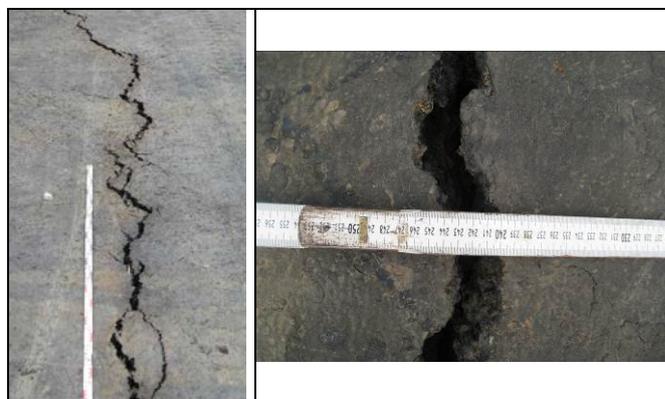
A careful inspection, executed after the complete exposure of the dam face, showed the existence of numerous open fissures located inside or immediately nearby the areas indicated by the tracer tests.

Figure 15: Open cracks on the bituminous asphalt layer exposed after reservoir drawdown

Complementary remediation measures focused on the rehabilitation of the bituminous layer with the sealing of the cracks and the installation of an impervious PVC membrane along the lower section of the dam face. Additionally a laterite blanket was re-placed at the upstream dam toe.

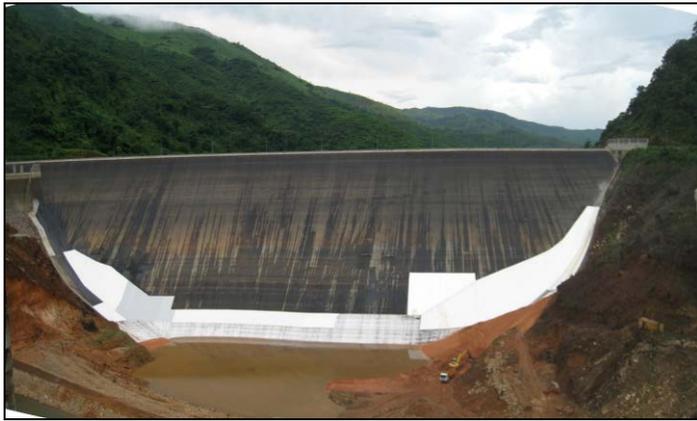
Figure 16: PVC membrane installed on the dam face.

The installation of the PVC blanket was completed in June 2010 (Figure 15), since then the dam is performing satisfactorily with flow collected by the foundation drains ranges between 35 and 90 l/s.
